DEPARTMENT OF TRANSPORTATION

Contract #: 04-0120F4Cty: SF/ALA Rte: 80 PM: 13.2/13.9File #: 99.28**WELDING INSPECTION REPORT****Resident Engineer:** Siegenthaler, Peter**Address:** 333 Burma Road**City:** Oakland, CA 94607**Report No:** WIR-018306**Date Inspected:** 28-Nov-2010**Project Name:** SAS Superstructure**OSM Arrival Time:** 700**Prime Contractor:** American Bridge/Fluor Enterprises, a JV**OSM Departure Time:** 1900**Contractor:** Zhenhua Port Machinery Company, Ltd (ZPMC)**Location:** Shanghai, China**CWI Name:** Li Yang and Zhu Zhong Hai**CWI Present:** Yes No**Inspected CWI report:** Yes No N/A**Rod Oven in Use:** Yes No N/A**Electrode to specification:** Yes No N/A**Weld Procedures Followed:** Yes No N/A**Qualified Welders:** Yes No N/A**Verified Joint Fit-up:** Yes No N/A**Approved Drawings:** Yes No N/A**Approved WPS:** Yes No N/A**Delayed / Cancelled:** Yes No N/A**Bridge No:** 34-0006**Component:** OBG Trial Assembly**Summary of Items Observed:**

WELDING INSPECTION REPORT

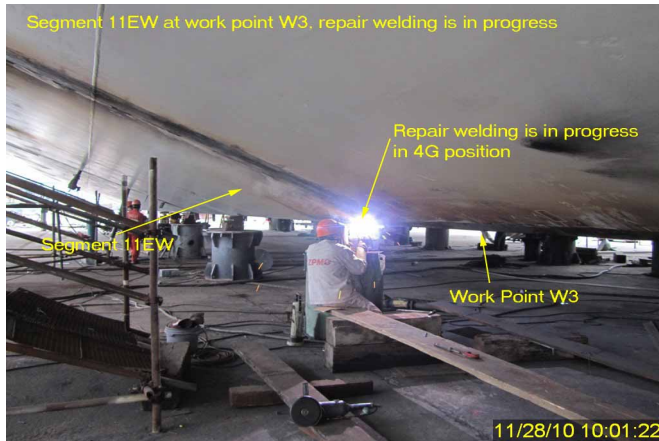
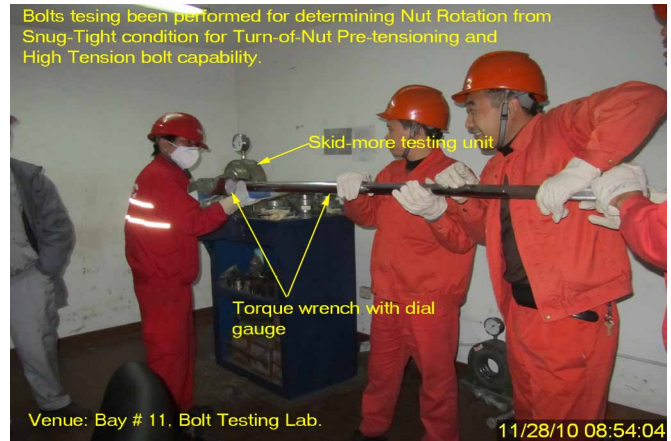
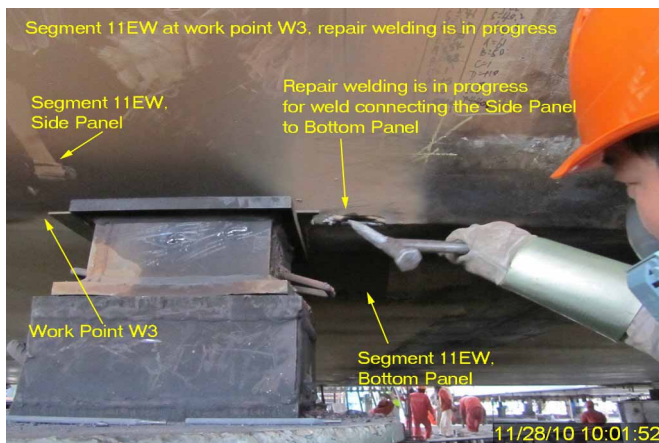
This QA Inspector observed the repair welding by Shielded Metal Arc Welding (SMAW) process on a Complete Joint Penetration (CJP) groove weld. The Weld joint was designated as Seg071A-044. The welder identification was 040611 and was observed welding in the 1G (Flat) and 4G(Overhead) positions using approved Welding Procedure Specification WPS-345-SMAW-1G(1F)-FCM-Repair-1 and WPS-345-SMAW-4G(4F)-FCM-Repair-1. The piece mark was identified as Side Panel to Bottom Panel hold back weld at work point W3. ZPMC performed repair welding in accordance with Critical Welding Repair Report B-CWR2301.

This QA Inspector observed the repair welding by Shielded Metal Arc Welding (SMAW) process on a Complete Joint Penetration (CJP) groove weld. The Weld joint was designated as Seg073A-014. The welder identification was 040611 and was observed welding in the 1G (Flat) and 4G(Overhead) positions using approved Welding Procedure Specification WPS-345-SMAW-1G(1F)-FCM-Repair-1 and WPS-345-SMAW-4G(4F)-FCM-Repair-1. The piece mark was identified as Side Panel to Bottom Panel hold back weld at work point W3. ZPMC performed repair welding in accordance with Critical Welding Repair Report B-CWR2301.

This QA Inspector observed the repair welding by Shielded Metal Arc Welding (SMAW) process on a Complete Joint Penetration (CJP) groove weld. The Weld joint was designated as OBW11C-007. The welder identification was 053871 and was observed welding in the 4G (Overhead) position using approved Welding Procedure Specification WPS-345-SMAW-4G(4F)-Repair-FCM-1. The piece mark was identified as the Side Panel, Counter Weight side. ZPMC performed repair welding in accordance with Critical Welding Report B-CWR2272.
